Geomorphological Analysis of Duhok Dam Site Using Remote Sensing Data

This study aims to analyze the geomorphological and geological features of Duhok Dam's sites and interpret the landforms and geological structures in this area. Field (observation) investigation, Satellite images and the data obtained from previous studies of this area have been facilitated in this study to make a compilation with each other to conclude a geological and geomorphological interpretation of landscapes. A Geomorphological map is prepared of the most dominant features. The Germawa strike-slip faults and their relation with the gully Duhok strike-slip fault are determined by their effect on the dam site. Sediments from erodible formations could decrease the dam reservoir capacity and flood waves during heavy rain and snow season could impact high pressure on the dam body so several sites were suggested to construct precautionary dams in anticipation of these risks. A seismotectonic situation for the dam area was also studied and determined, requiring officials to continuously monitor the dam body and its foundation.

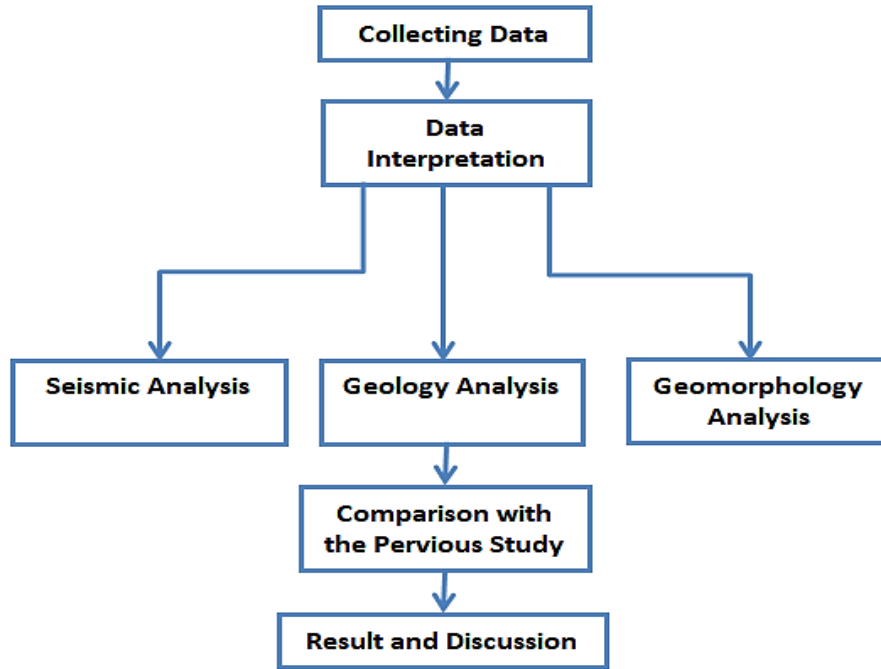
Fig. 2. The Methodology and structure of the work.

This research relied on field observations, geological and geomorphological analyses, in addition to previous studies of the study area. Satellite images embedded in Google Earth were used to illustrate geological analyses and interpretations of the study area. The seismic record of Iraq from 1960 to 2022 (EMSC) was also used to discuss and illustrate potential risks to the study area. Fig 2 shows the work methodology and stages.

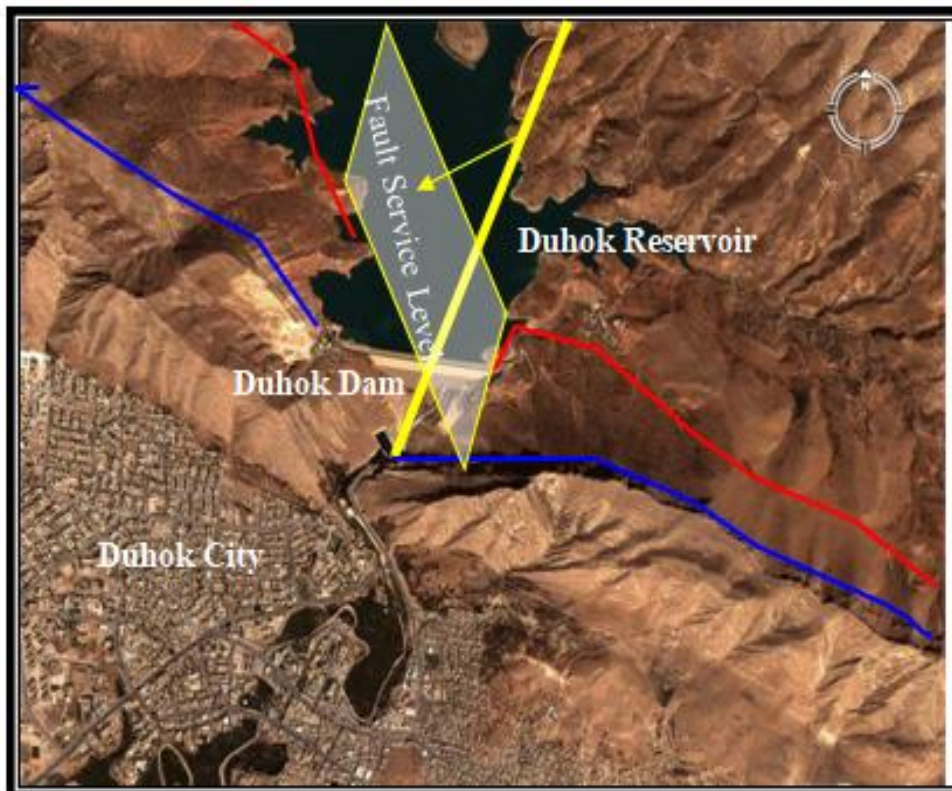
Fig. 6. The displacement of the striking faults in the Bekhair Anticline (Al-Hubaiti, 2008)

The indications for the existence of a Dextral Strike-Slip Fault at this fault are the displacement of the Pil-Spi Formation and the dextral deviation of the axis of the anticline (Al-Hubaiti,2008). Also, the thickness of the Gercus Formation (450 m) to the east of the fault is less than the thickness of the same formation, about (700 m) to the west of this fault. The same case is concerning the Pila-Spi Formation as well, (Fig. 6).

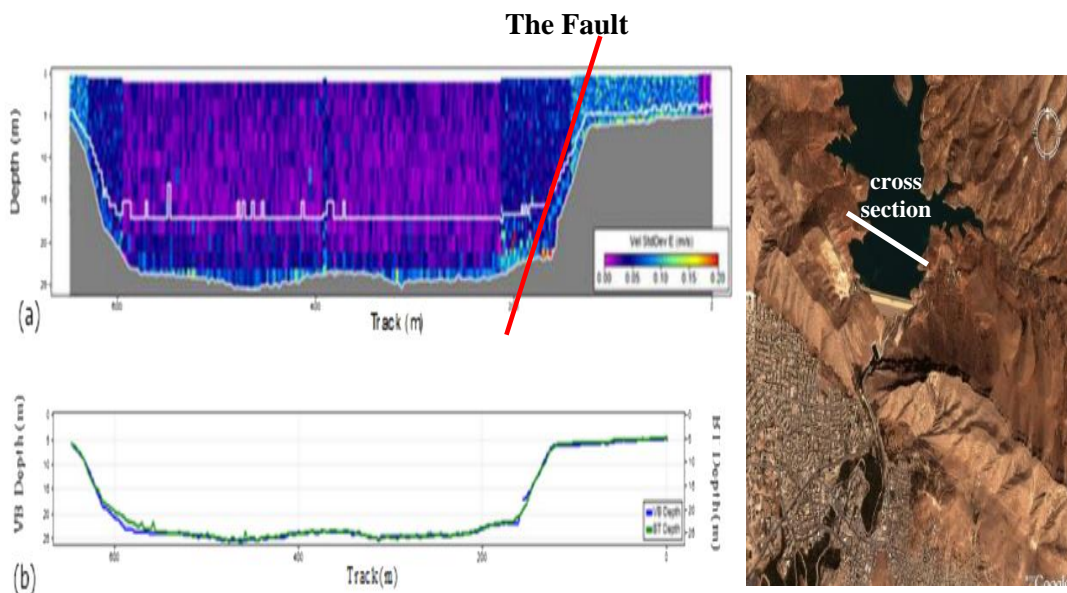
Fig. 7. Cross-section of the bottom of the reservoir (Abdulrahman, et. al., 2017), showing the supposed fault location.

The transverse cross-section of Duhok reservoir near the dam according to the study conducted by (Abdulrahman, et. al., 2017), it is clear that the location of the fault corresponds to the cross-section of the reservoir, (Fig. 7).

As a result, it is noted that the left shoulder of the dam is subjected to great pressure if a high rain falls, (Fig. 7), and that the left shoulder of the dam is located on the fault plane, and it works to shift it slightly, which increases the expansion of the cracks in the dam body, and so on, until it reaches a dangerous stage of disintegration of the dam body over time.

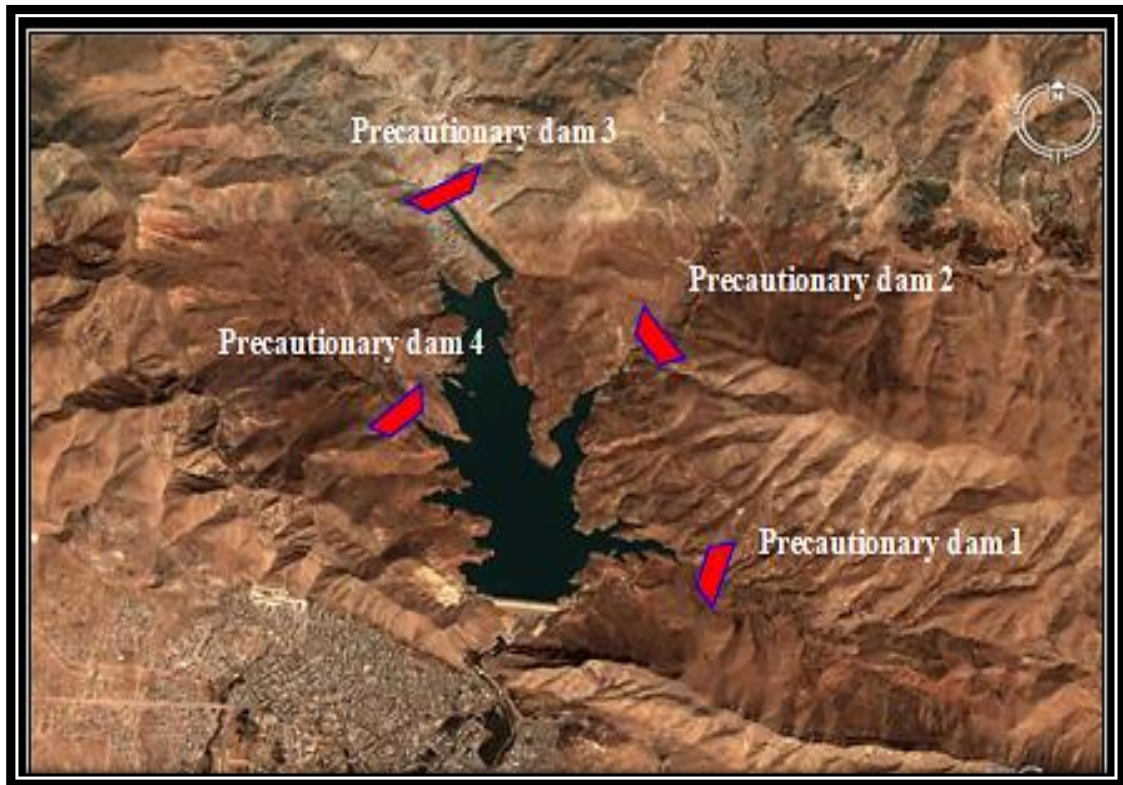
Fig. 10. The places of construction of precautionary dams in the study area

Accordingly, and to overcome the probable consequences (Fig. 10), several sites were suggested to construct precautionary dams in anticipation of these risks.

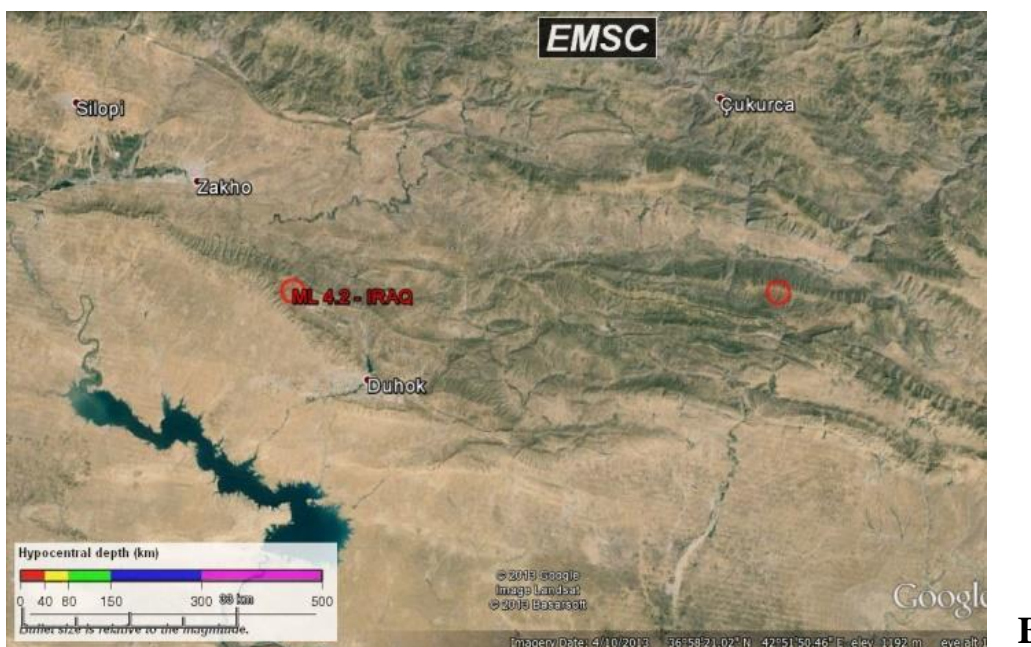
Fig. 11. A- The seismic record of Iraq from 1960 to 2022 (EMSC). B- View of the earthquake that occurred near the study area.

The study area is located within a seismically active range, which makes the occurrence of earthquakes highly likely, especially since the recorded history of earthquakes that occurred in the study area from 1960 to 2022 contained several foci of recorded earthquakes with intensity greater than 3 on the Moment Magnitude Scale (MM scale), (Fig. 11-a), also the study area was subjected to earthquakes close to the body of the dam, with a magnitude of 4.2 on the MM scale, with two earthquakes (Fig. 11-b) it works to break the dam body and collapse it (Bayraktar and Kartal, 2010).
